MINING COMPLEX "KOLUBARA" L A Z A R E V A C

Branch of KOLUBARA METAL

STATEMENT

About using Polytron products: Polytron EP-2 Lithium Complex Grease and Polytron PL

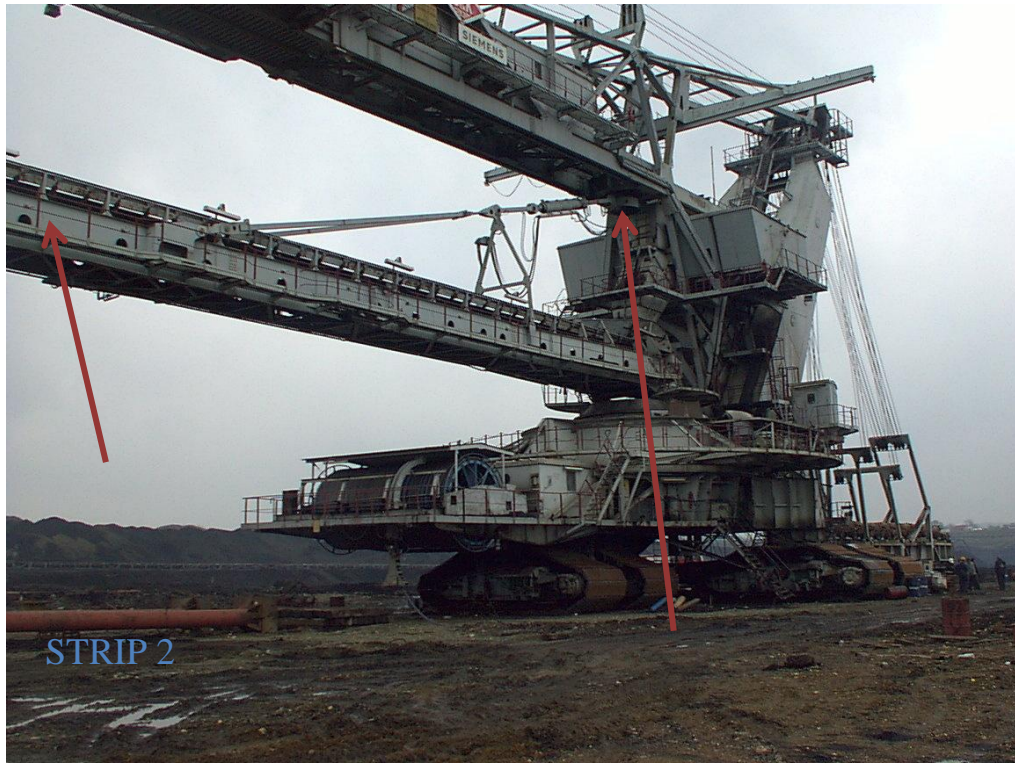
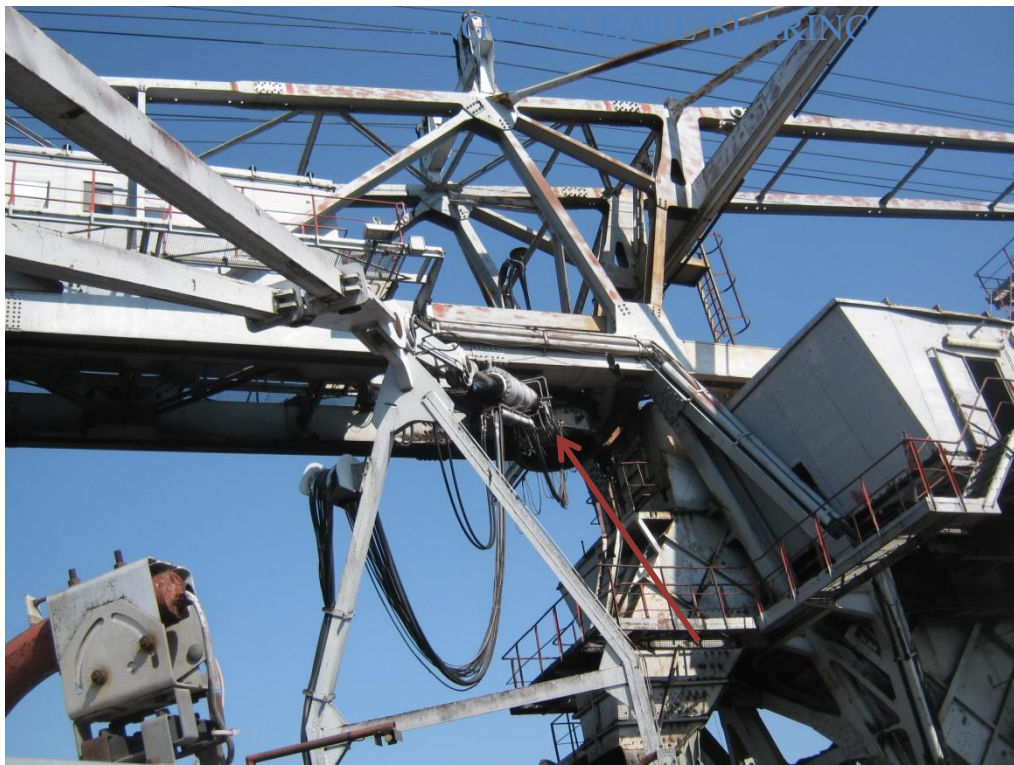
Image 3

During May to June 2012, this Bucket Excavator went through a scheduled overhaul, which included disassembly, reconstruction and assembly of angular ball bearing from wear strips, Strip 2 – Images 3 and 4.

The main reason for the above repair operation was appearance of inormous resistance to rotational motion of Wear Strip 2 indicating that its angular ball bearing was failing and required full repair.

The angular ball bearing was taken off the strip and brought to "Kolubara Metal" workshop , where it was disassembled, cleaned, washed and lubricated with Polytron PL and Grease as discribed below.

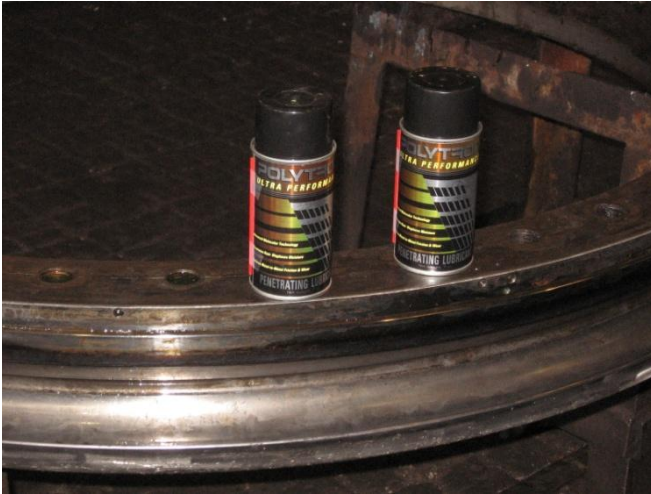
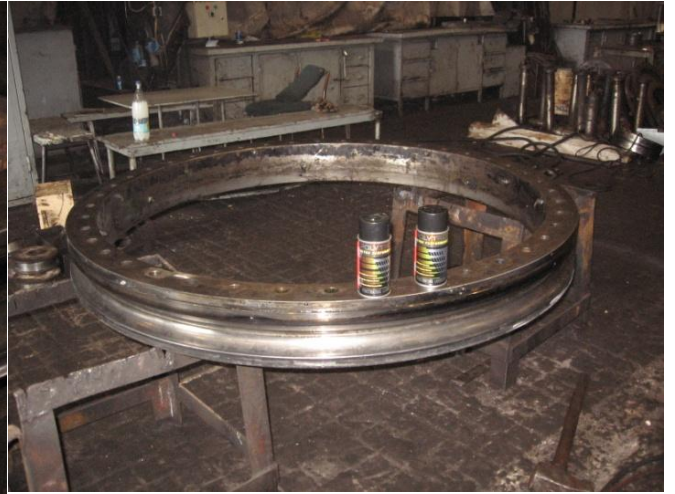
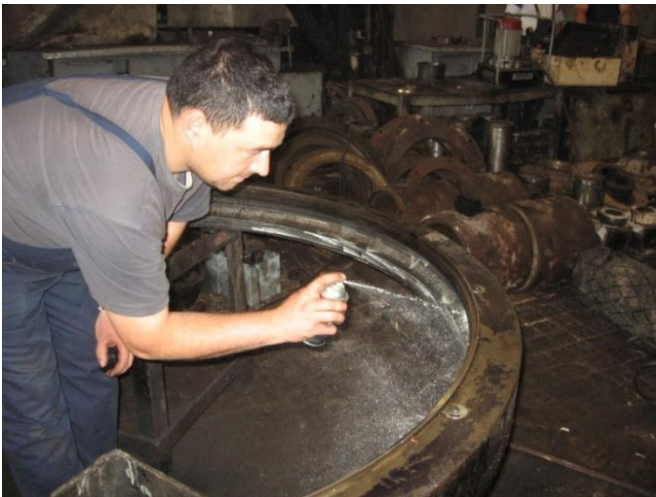
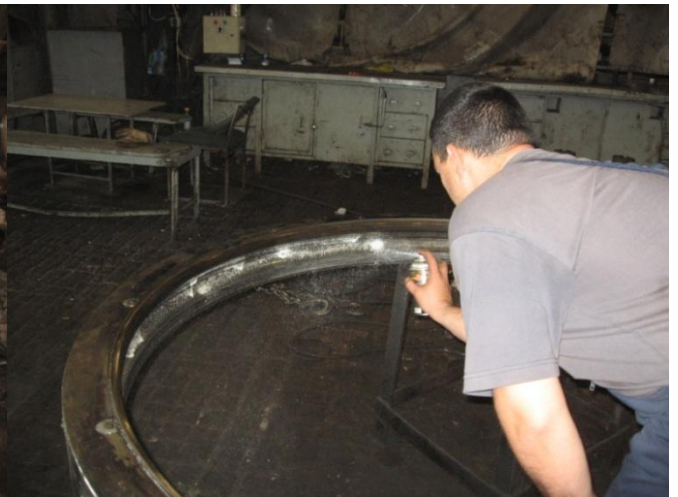
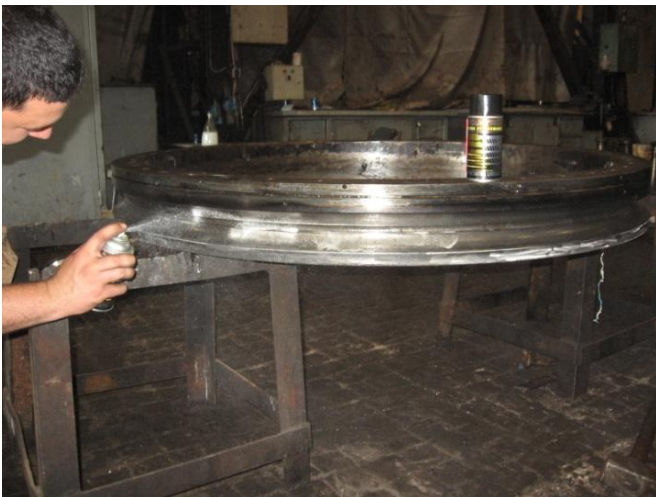
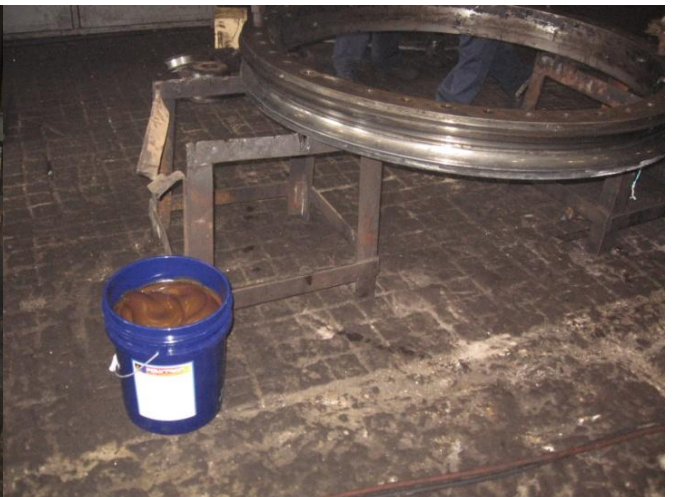
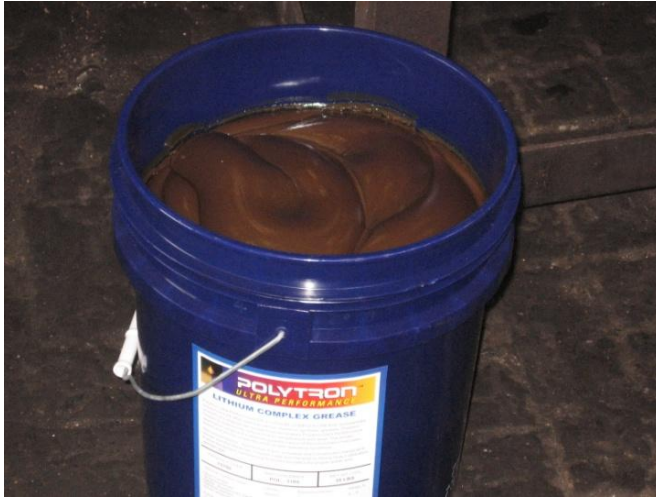
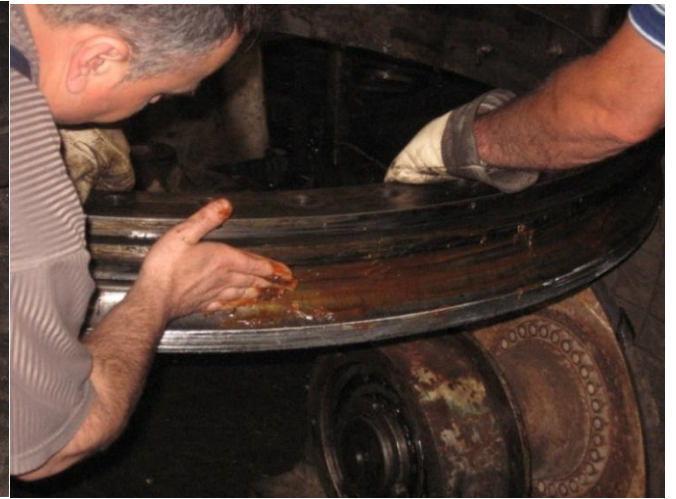
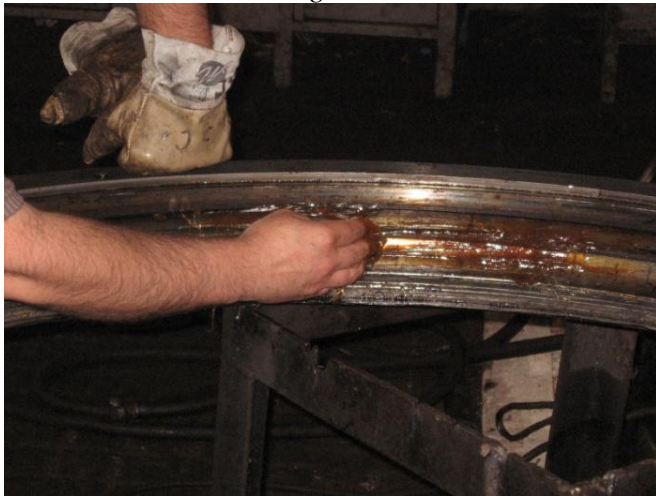
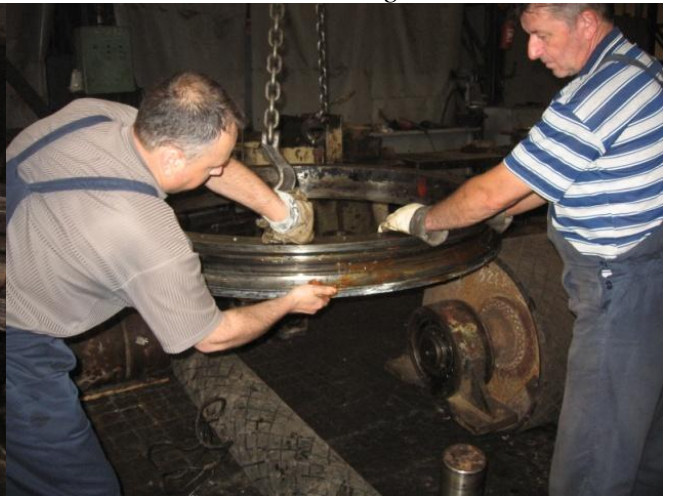
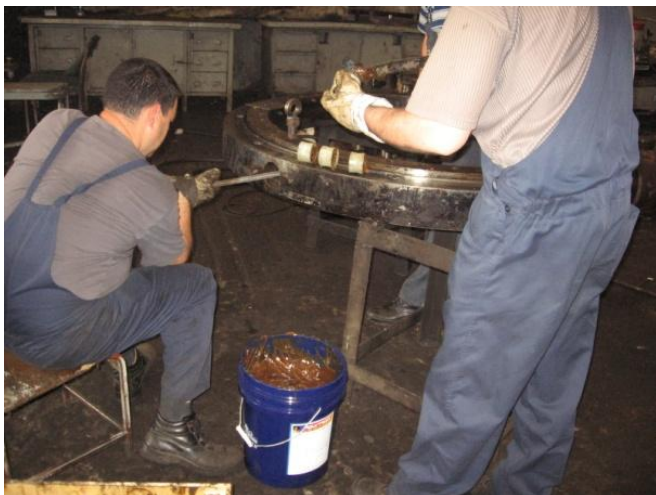
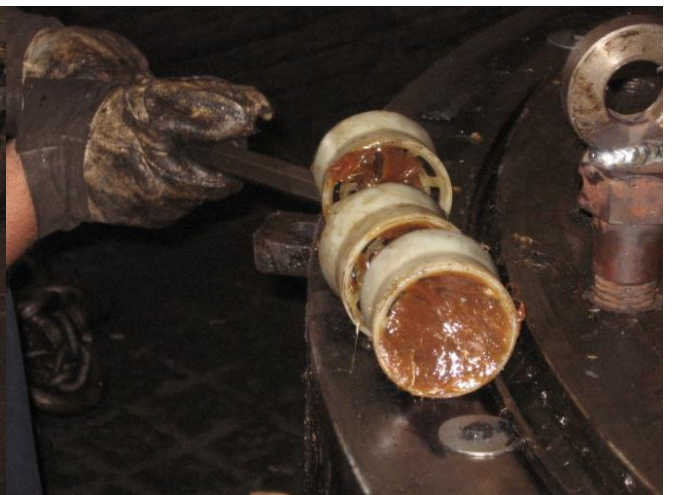
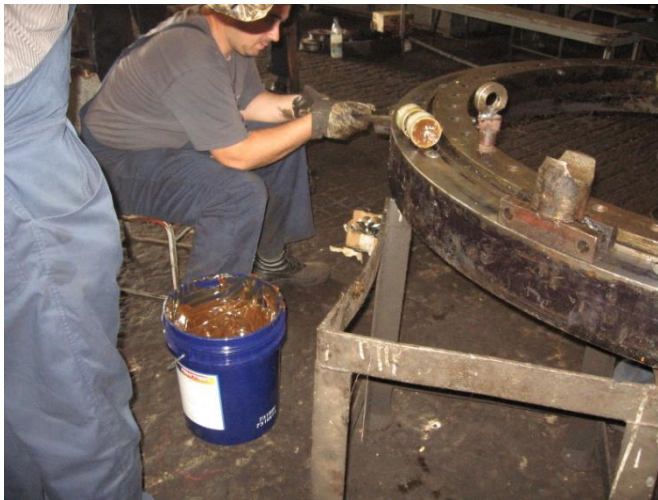
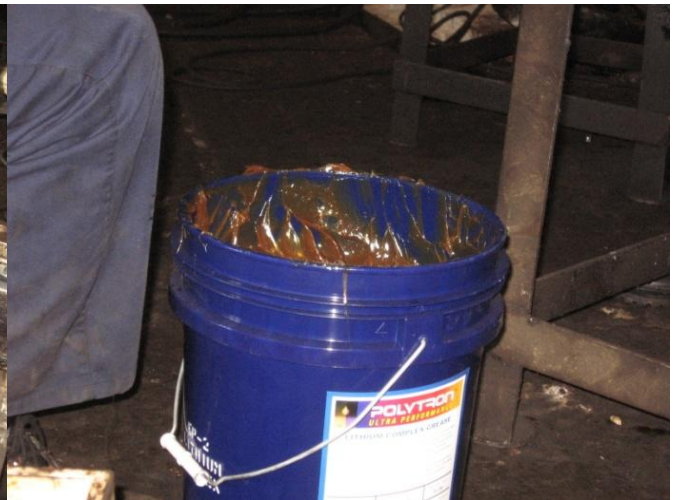
The application of Polytron products was done under the supervision of your representative in Serbia (see Images 5 to 18).

Since June 2012, when the above mentioned Angular Ball Bearing was repaired and lubricated with Polytron PL and Grease, until today, March 2014, it operated smoothly without interruptions and without any maintenance operations beyond routine lubrication, as opposed to need for some type of repairs every 6 months before Polytron products were applied.
