MINING COMPLEX "KOLUBARA" LAZAREVAC

STATEMENT

About using Polytron product: Polytron EP 2 unguent and Polytron PL

One of that machines that works on Surface mine "Tamnava" West Field and that on the excavation of coal is Bucket excavator ERs 1000/20, image 1.

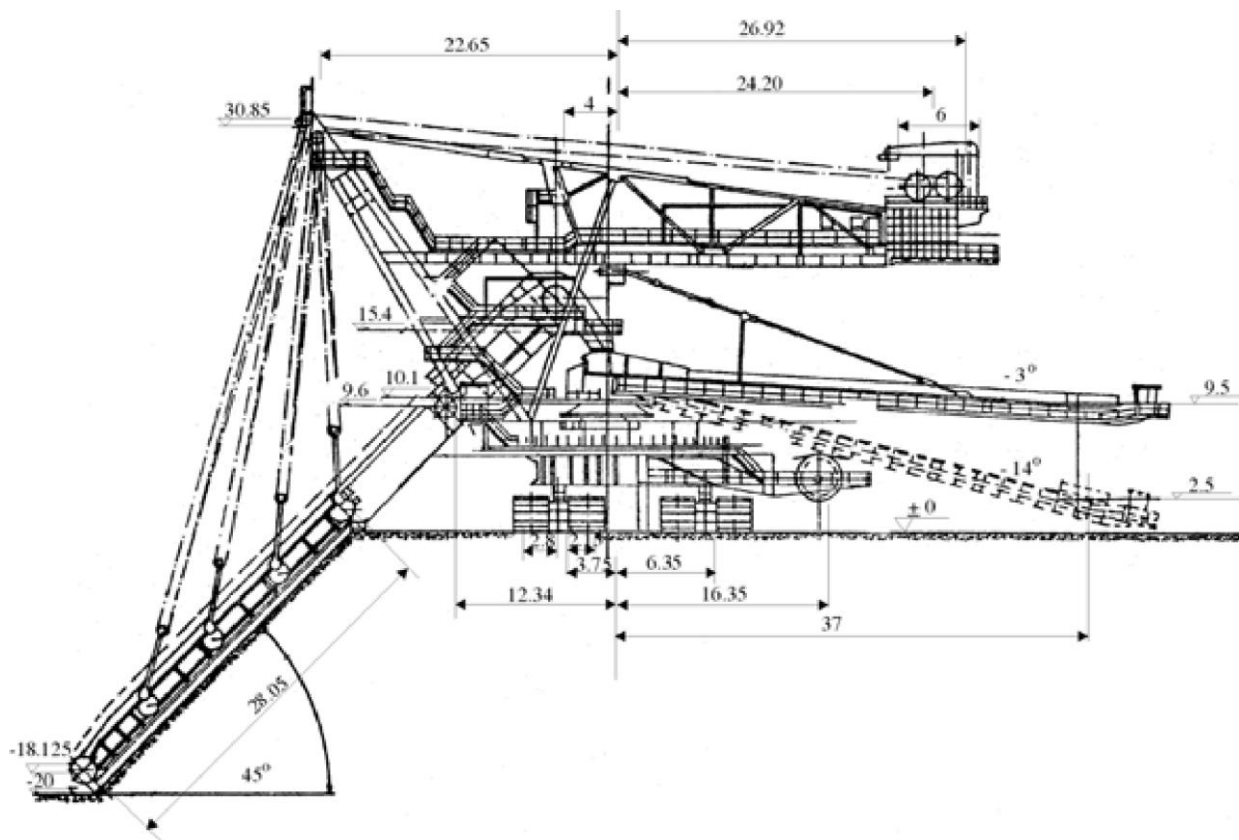
Image 2 – Major dimensions of Bucket excavator ERs 1000/20

Major dimensions were given at image 2;

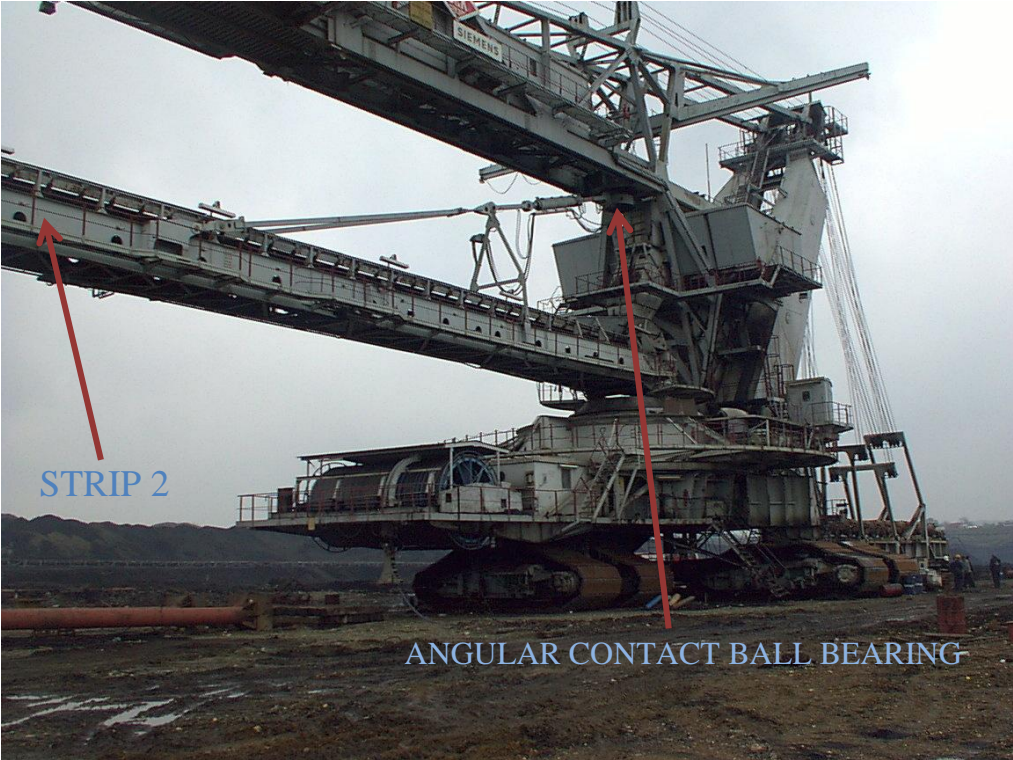
One of the operations was also and removal, regeneration and montage of angular ball bearing from wearing deponent strips, Strip 2 – Image 3 and Image 4.

The main reason of performing the operation was that because during the work started to appear huge resistances during the rotation of deponent Strip 2, that was indicated on the damage of angular ball bearing.

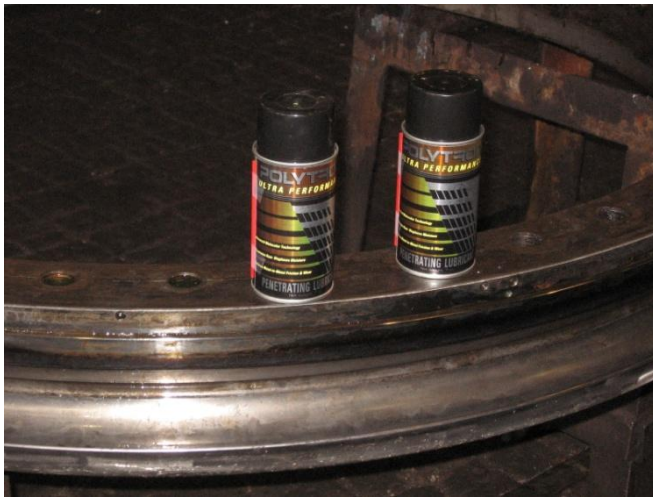
After dismantling and transport at workshops of "Kolubara Metal" was performed dismantling of angular ball bearing, cleaning and washing, and also defectation. Image 5 and 6.
