MARBLE SAND QUARRY NICHLOS BROTHERS S.A.

STAVROS AGIOY NIKOLAOY 72100

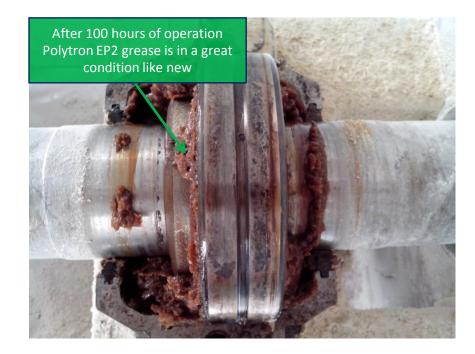
In this photo we see the slightly worn out No.2 bearing. As mentioned, this noisy bearing after it was lubricated with Polytron EP2 grease the, the noise has almost completely gone.

Since then Polytron grease has worked more than a 100 hours and still it is clean like new. It keeps exactly the same color and quality. For your information the bearing is barrel heavy duty type and the shaft rotates in 3,000 rpm.

Furthermore, no grease leaks occurred during its operation the way it was happening before using Polytron grease, which means that the maintenance intervals can be considerably extended.

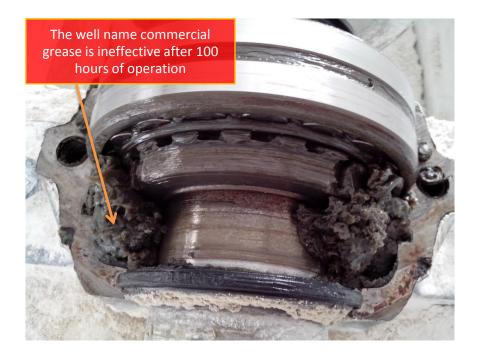
In this photo we see the well name commercial grease after around 100 hour's operation in a similar bearing that we opened for inspection. The grease is ineffective in a dark color, and if you touch it, you will get a sense like wet bran. This grease when it was new had a light yellow color.

The bearing has grease leak also due to high pressures and temperature and it needs close inspections and supplements.
