MINING COMPLEX "KOLUBARA" L A Z A R E V A C

Branch of KOLUBARA METAL

STATEMENT

About using Polytron products: Polytron EP-2 Lithium Complex Grease and Polytron PL

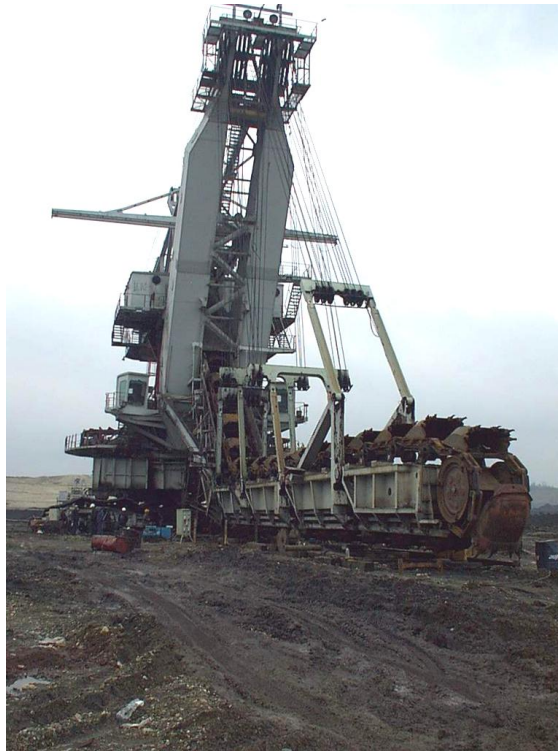
Image 1 - Bucket Excavator ERs 1000/20

Bucket Excavator ERs 1000/20 (image 1) is one of those machines that operate in the quarry "Tamnava" West Field on excavation of coal.

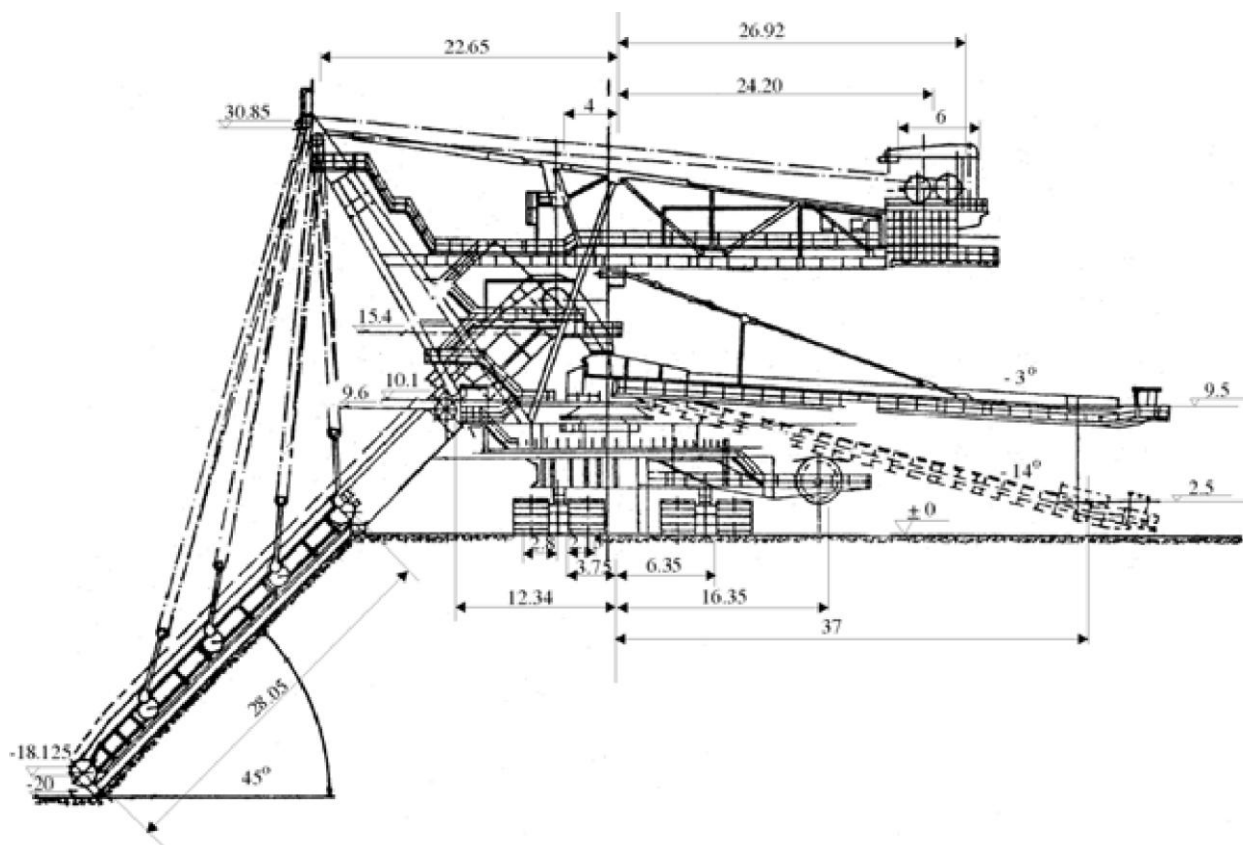
Image 2 – Major dimensions of Bucket excavator ERs 1000/20

Major dimensions were given at image 2;
